METHODOLOGY AND EFFECTIVENESS OF
DRAINAGE SYSTEMS FOR AIRFIELD PAVEMENTS

TECHNICAL REPORT C-13

Systems Approach to Life-Cycle Design of Pavements

by
Harry R. Cedergren

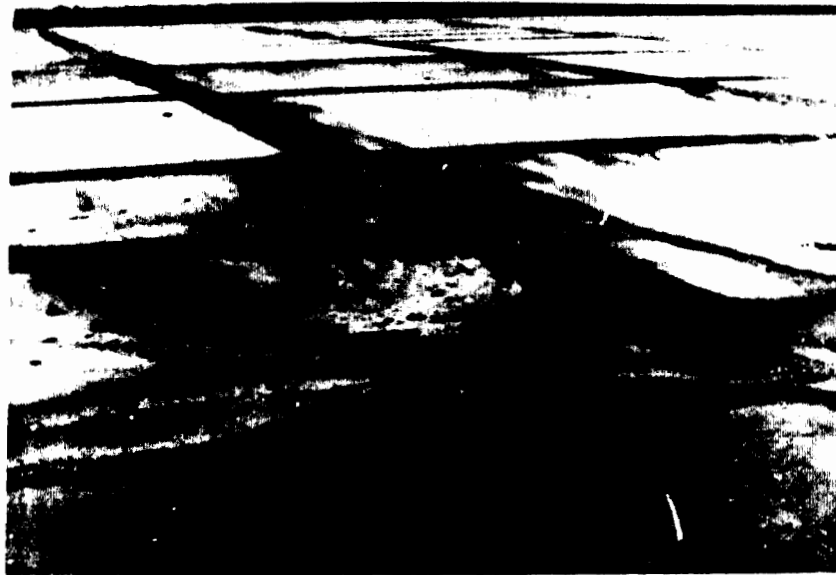
Figure 2. Photo of a poorly drained PCC pavement that has been severely damaged by excess water, and extensively repaired.

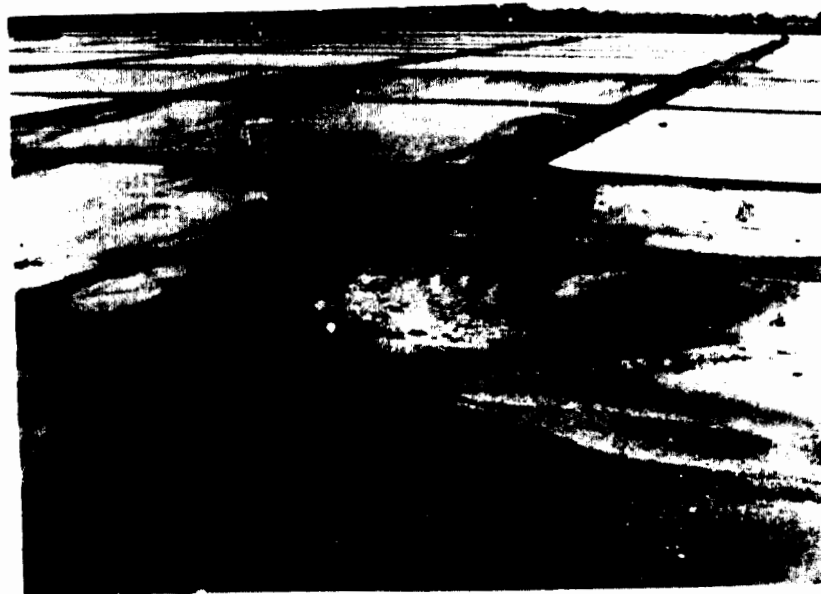
Figure B-19. Extensive damage of pavements; repair of joints has been required; much excess water and bleeding; free water coming out several days after a rain.

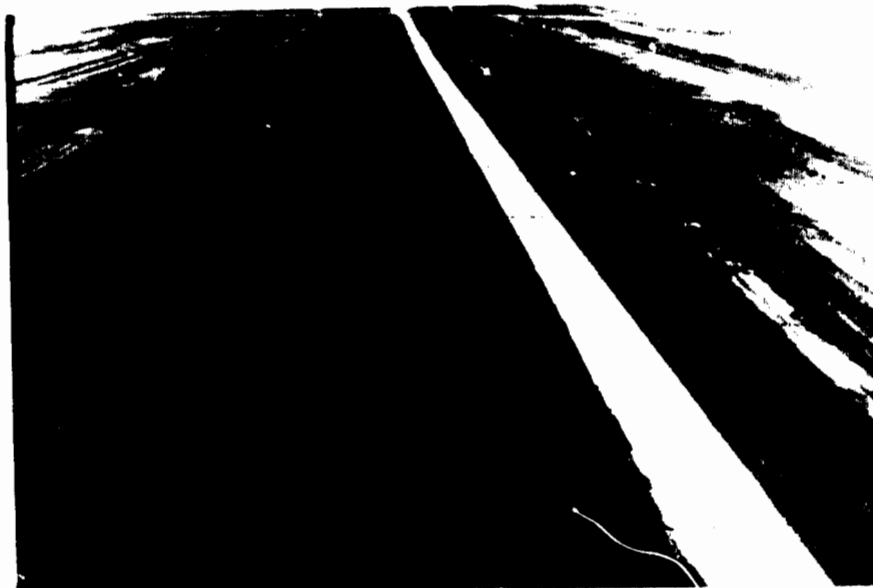
Figure B-34. Extensive reflection cracking in 2-1/2 inch AC
overlay on PCC pavement.

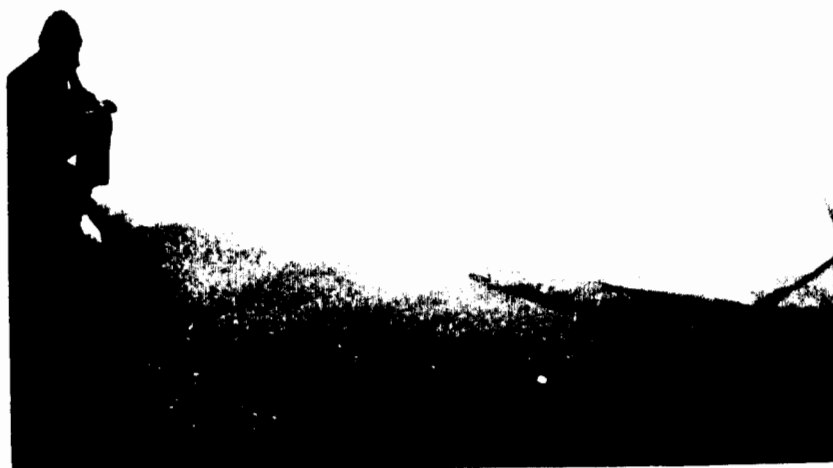
Figure C-14. Cross view at Wells 4 and 5 several hours after a rain; shows wet condition; officer is at Well 5.

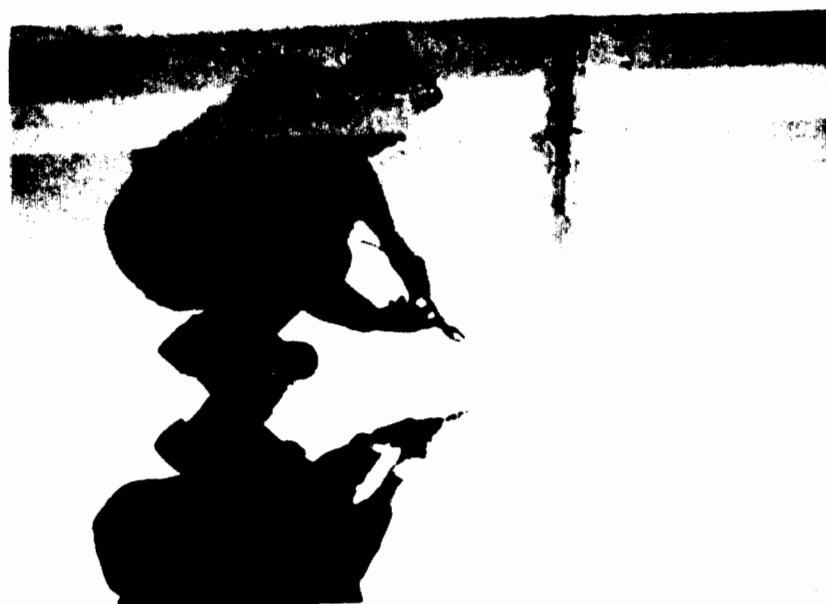
Figure C-15. View at Well 4, same time as Fig. C-14; about 1/2 in. of water over pavement and well.

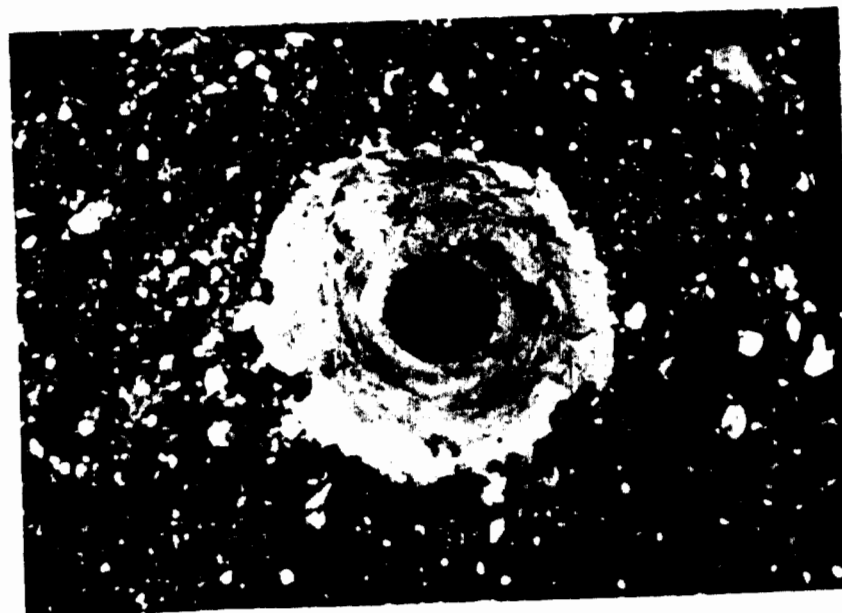
Figure C-16. Close-up of Well 5 several hours after a rain; pavement is damp, but no surface water; hydrostatic head in base raised water to 1 in. from top of pavement.

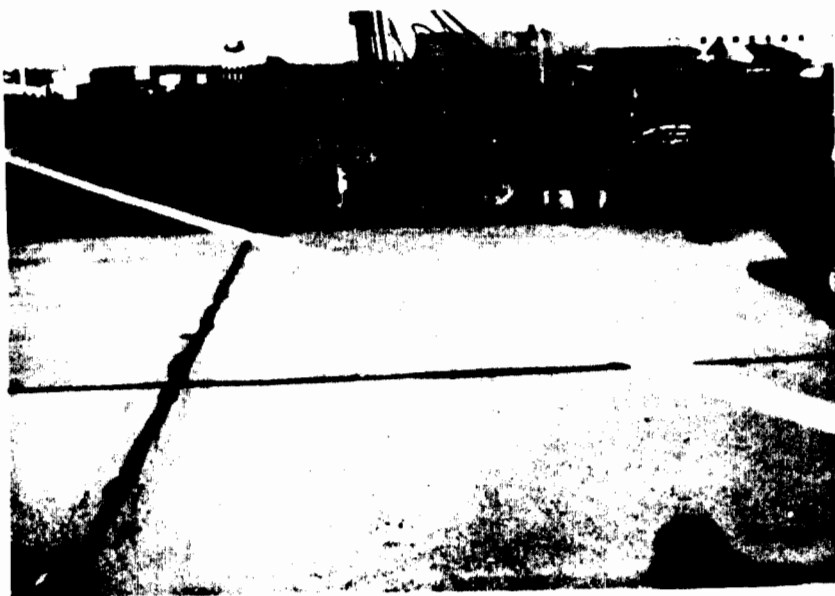
Figure D-4. View of drilling equipment at Well 6; is in 20-in. thick PCC at SW Warm-up Apron and Taxiway: dark stains suggest some bleeding may occur here: no excess water at time of drilling.

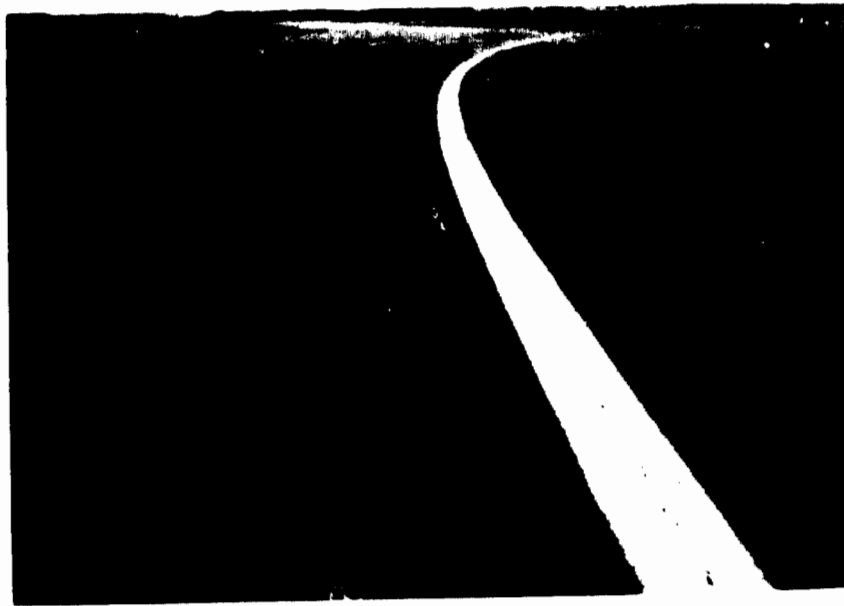
Figure E-13. Photo of NE Warm-up Apron near site of Wells 9 and 10 (installed later); crown area appears to drain rather rapidly, lower edge does not; Well 9 was drilled near the crown, Well 10 near far left edge; photo taken 9-1-72; wells drilled 10-18-72.
